HOUSATONIC RIVER BASIN
SHELTON, CONNECTICUT

SHELTON RES. NO. 2 DAM
CT 00093

PHASE I INSPECTION REPORT
NATIONAL DAM INSPECTION PROGRAM

SEPTEMBER 1980

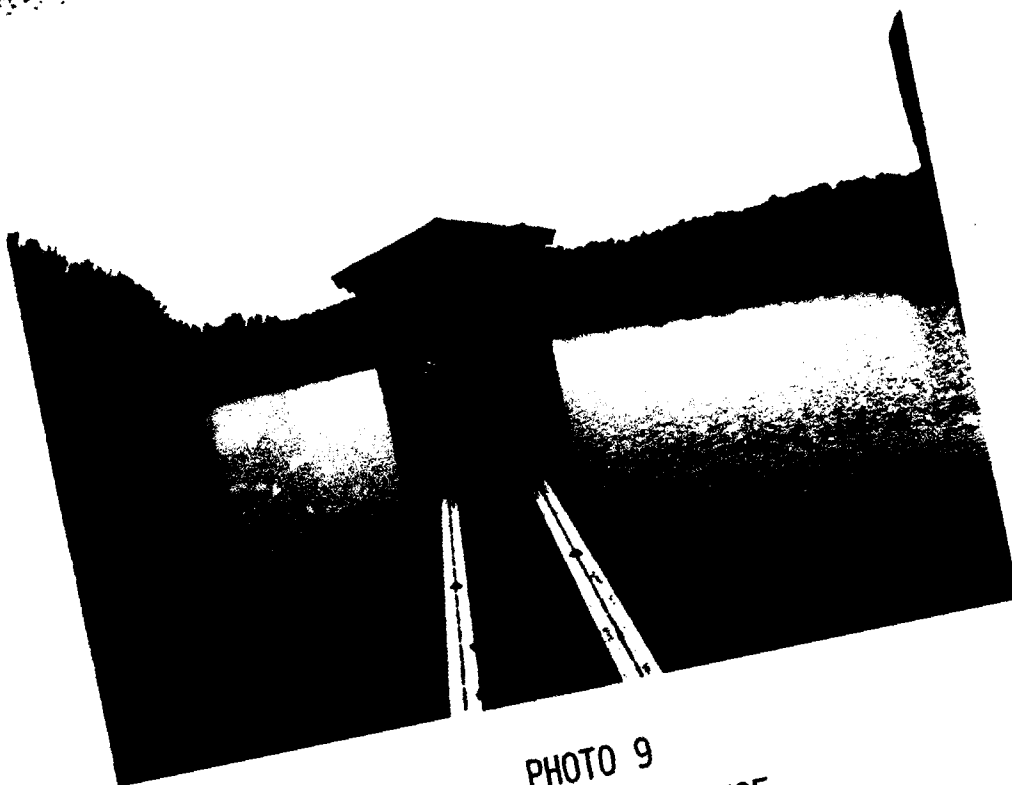
Both the upper and lower gate houses are in poor condition (Photos 8 and 9). The deck of the service bridge to the upper gate house is missing and the support beams are rusting away. The lower gate house is in better condition, however, trespassing is a problem. The water main that was controlled by the gates in the gate houses is not operable and is plugged.

PHOTO 9
UPSTREAM GATE HOUSE

- d. The condition of the low level discharge pipe and valve should be evaluated and both pipe and valve be made operable.
- e. The bridge to the upper gate house should be repaired.
- f. Prepare a detailed hydraulic/hydrologic study to determine spillway adequacy and an increase of the total project discharge if necessary.
